COMPARATIVE PERFORMANCE OF EPDM RUBBER ROOFING MEMBRANE AS PROTECTION AGAINST HAIL DAMAGE

*By Ric Vitiello
President*

*Forensic Roof Consulting and
Hail Damage Assessment Training*
www.benchmark-services.com

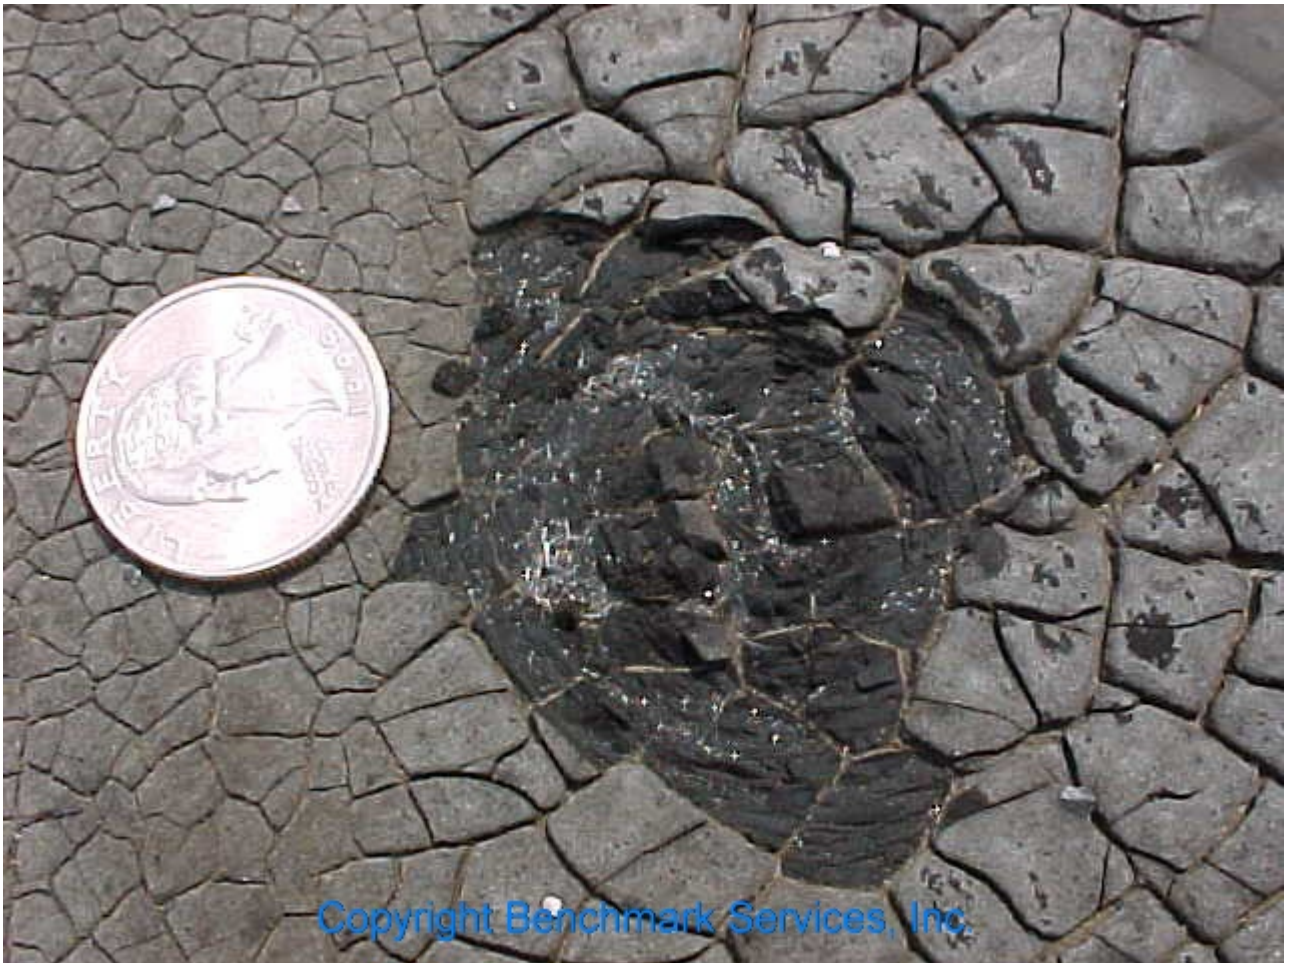
Figure 2 - Built -up roof damaged by 1 1/2" hail

Smooth surfaced or gravel, the result is the same. The asphalt or pitch is displaced or cracked at the surface and the fiberglass felt may be fractured allowing water infiltration and the beginnings of premature deterioration. Water infiltration into the insulation may spread and what begins as a small puncture may become a large repair. Multiple hail blemishes may require tear-off and re-roof as the only practical remedy. The photo in figure 2 below shows a hail impact fracture on a smooth surfaced asphalt built up roof.

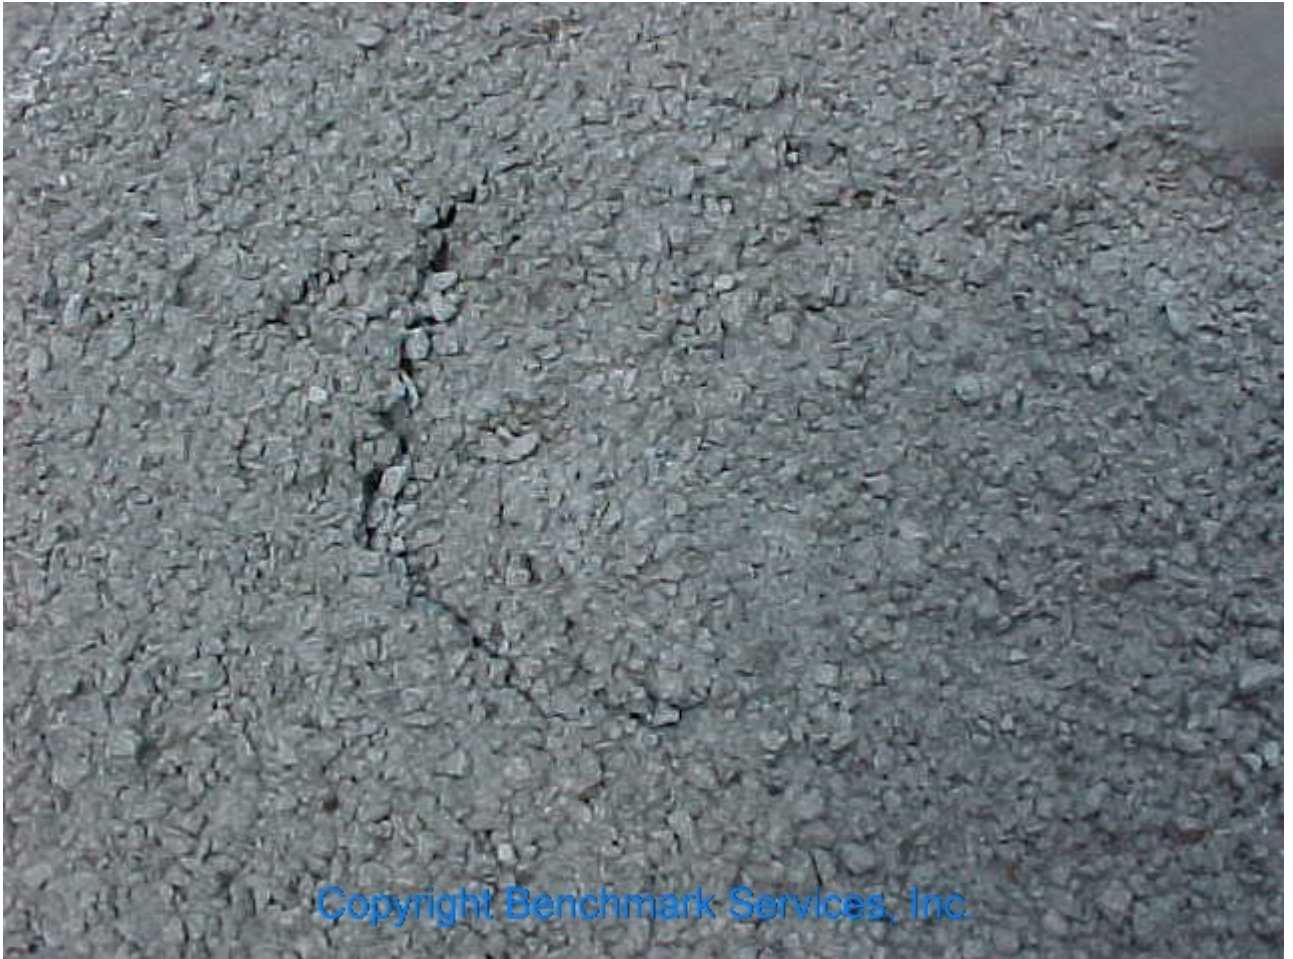
Figure 3 - Hail Damaged granule surfaced SPUF Roof

SPUF (Sprayed Polyurethane Foam) roofs are popular in some areas where hailstorms are becoming more frequent. Although the foam is closed cell and may not leak immediately after damage by hail, the required repairs to this type of roof can be very costly and the fractures can be particularly difficult to find on some of the newer granule surfaced systems. Hail damage on these roofs can be repaired unless the number of hail fractures is very large which then may require tear-off and re-roof or at least scarifying of the surface and re-coating. The photo in figure 3 reveals a fracture of the SPUF coating caused by hail impact approximately 1 1/2 inch in diameter.

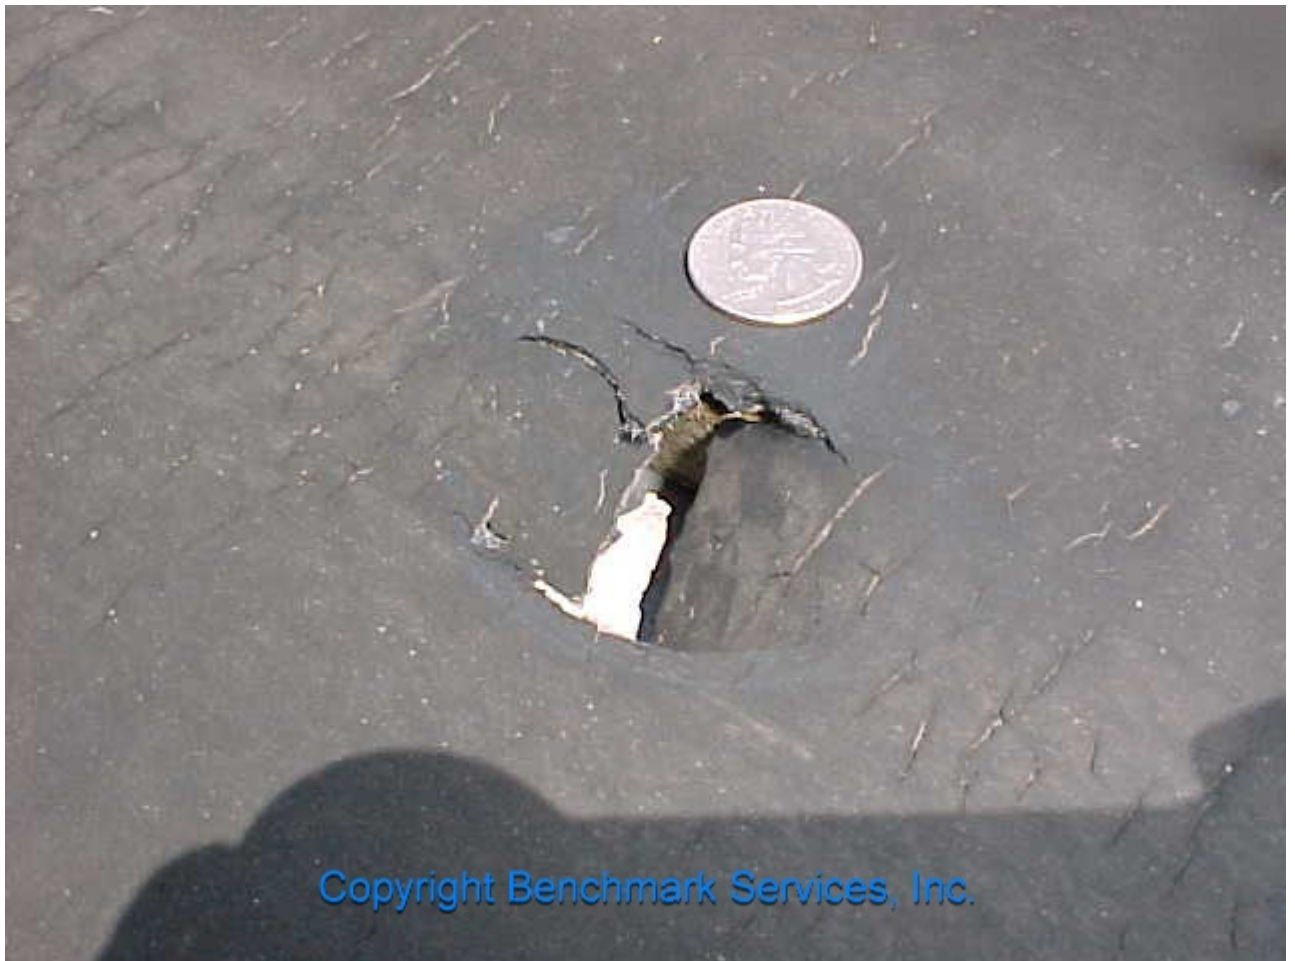
Figure 4 - APP Modified Bitumen Punctured By Hail

Because of this, the membrane is protected by a granule surface. This granule surfacing may be displaced by hail impact and even though the membrane is not fractured, it would require replacement due to the granule displacement. Both APP and SBS membrane systems can be damaged by hail impact since they are still asphaltic products. The photos in figures 4 and 5 show an unsupported area on a smooth surfaced APP membrane and an SBS granule surfaced membrane. Both were damaged by approximately 1 ½ inch diameter hail.

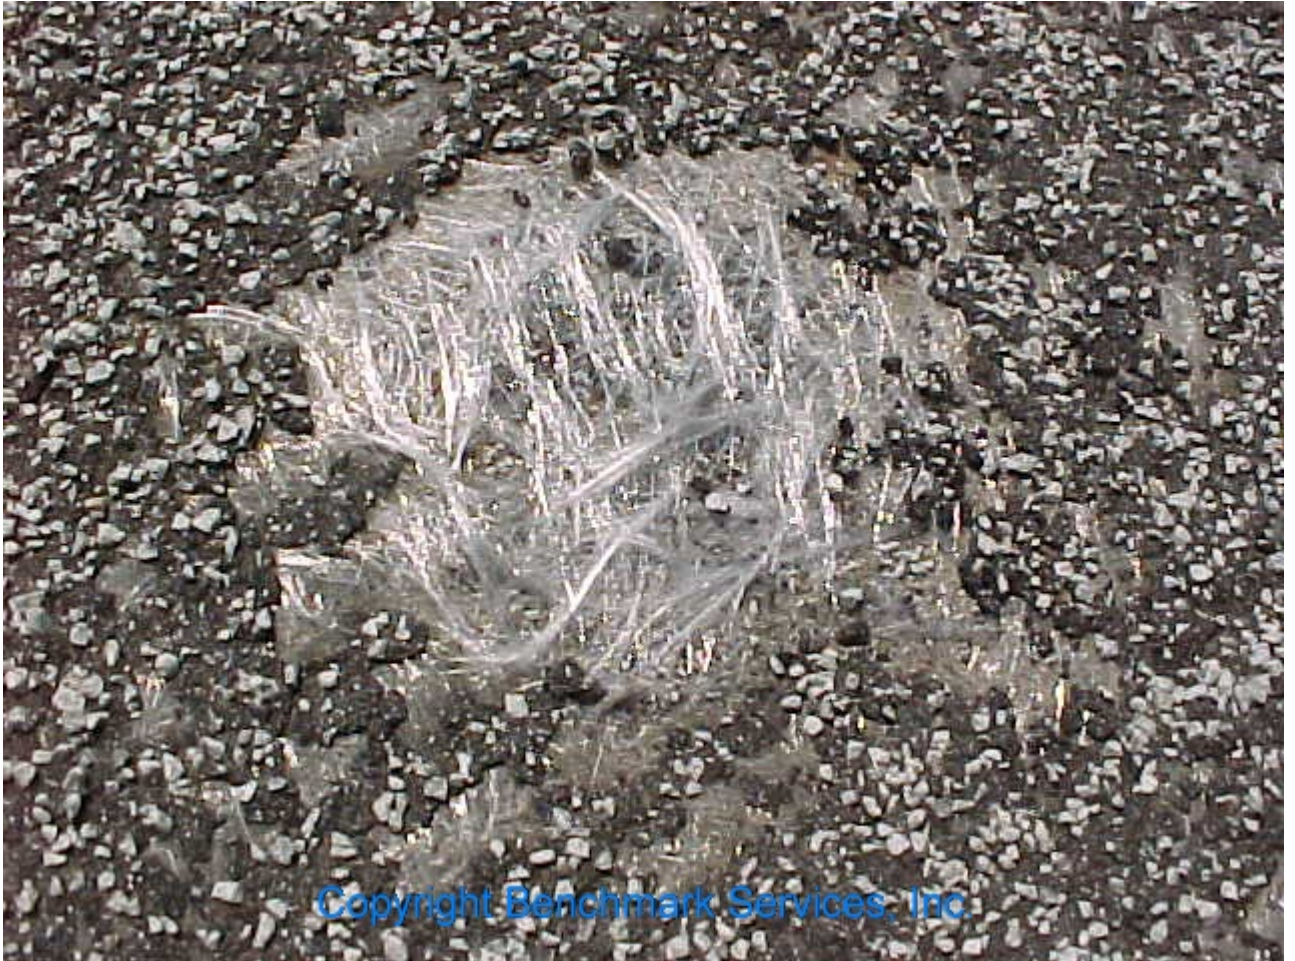
Figure 5 - SBS Modified Bitumen Roof Granule Displacement Caused By Hail

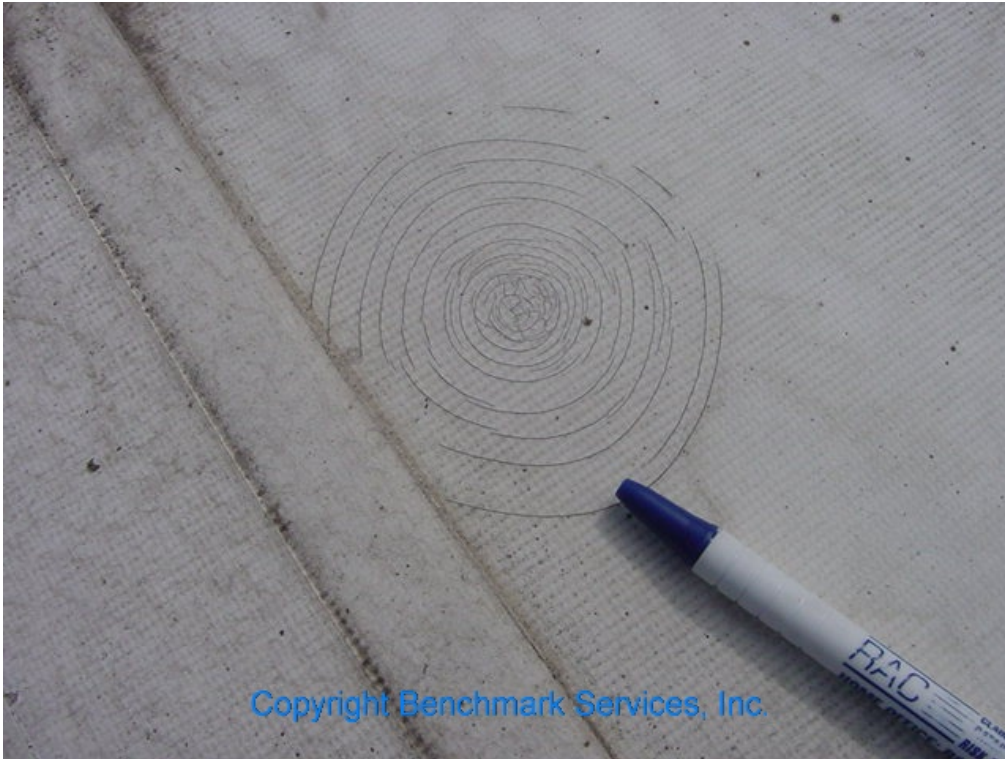
Figure 6 - Reinforced PVC Membrane Hail Fractured

The type of plasticizer used can make a great difference in whether the membrane becomes brittle as it ages and then more vulnerable to hail damage. PVC membrane is typically reinforced with a polyester fabric but some of the older types were not. The following photos in figures 6 and 7 show PVC roofs that have been impacted by $\frac{3}{4}$ inch to $1\frac{1}{2}$ inch hail. The first is reinforced and the second is not. The circular fractures eventually transfer through the membrane and develop into leaks.

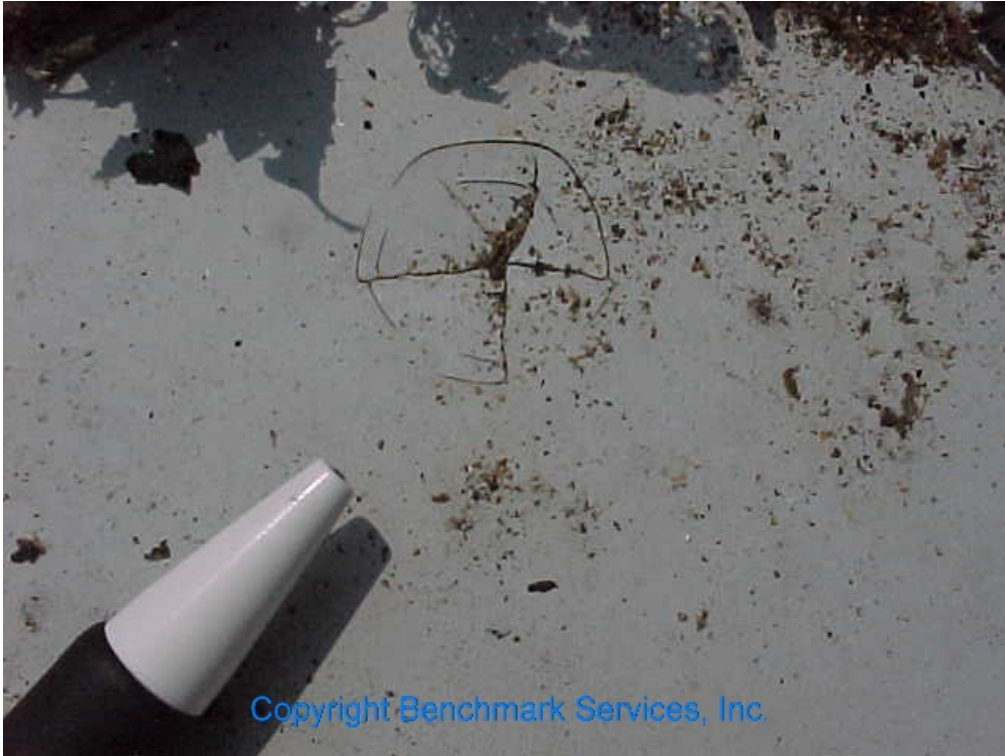
Figure 7 - Non-Reinforced PVC Membrane Damaged By Small Hail

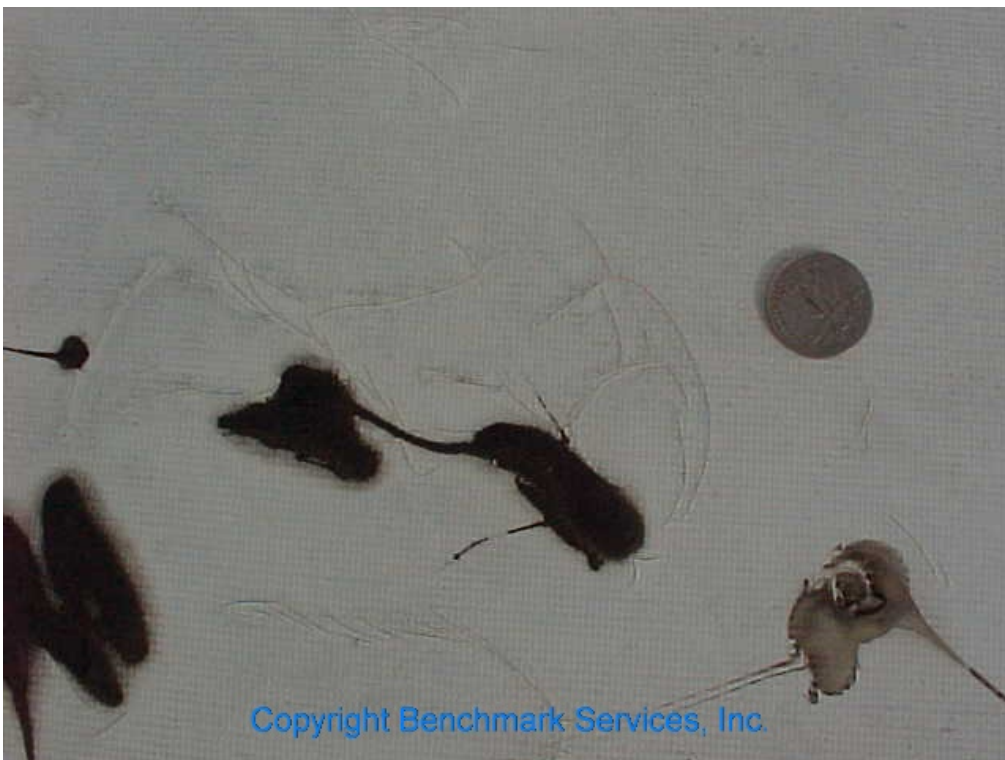
Figure 8 - Hail Damaged Reinforced PVC Membrane, Temporary Caulk Repairs

The last two photos in this series are figures 8 and 9. They show a PVC roof approximately three years after a hailstorm. Repeated repairs were done with various types of surface caulking until the owner finally realized that it would not be possible to seal all of the hail fractures that continued to open up and leak.

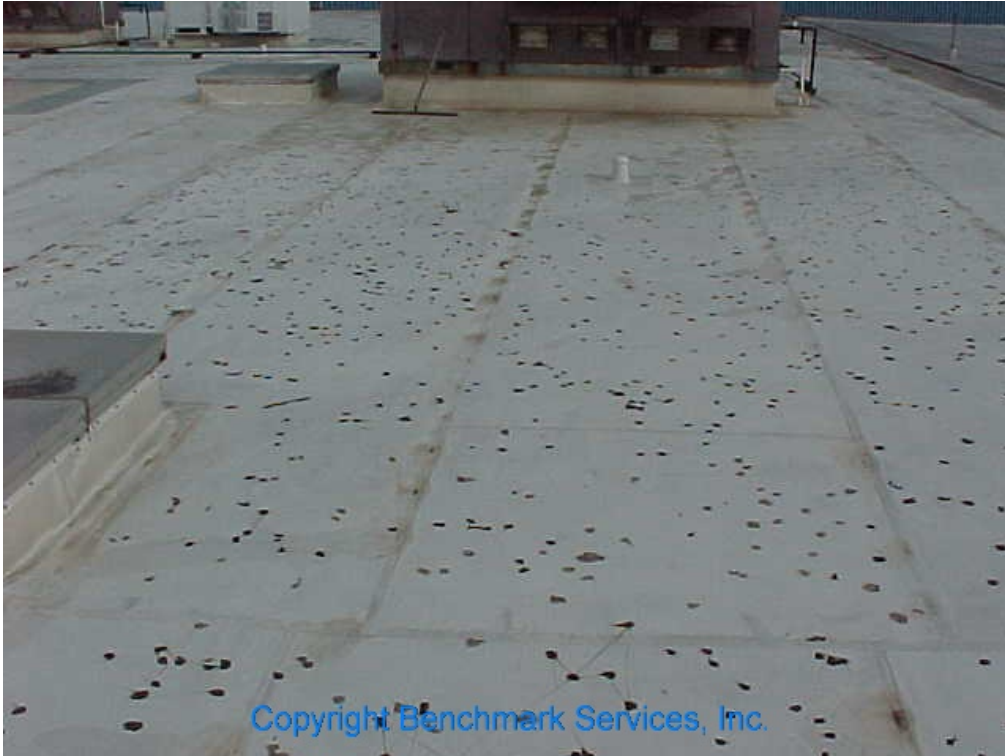
Figure 9 – Hail Damaged PVC Membrane With Thousands Of Temporary Caulk Repairs

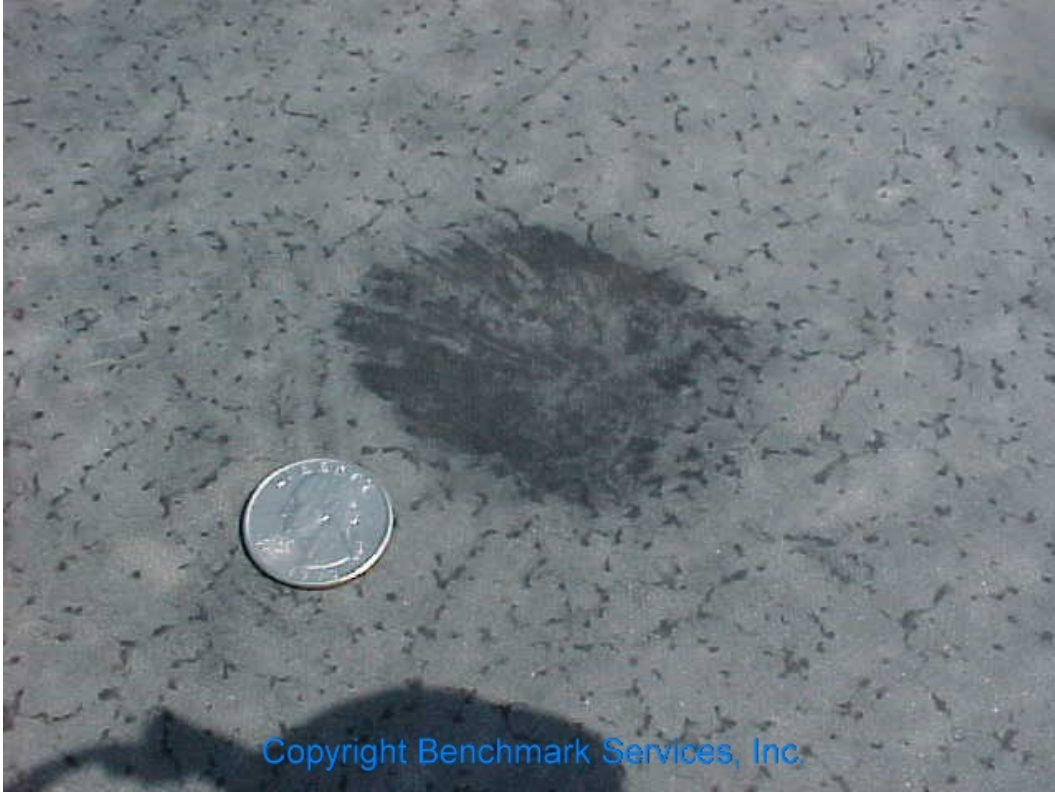
Figure 10 - EPDM Membrane Impacted by 2 1/2" Hail, No Membrane Damage

EPDM roof membrane provides benefits similar to some other popular membranes like low installation cost, low life cycle, maintenance and repair costs, quick installation and it can even be coated with white acrylic coating to improve its energy efficiency. In addition to all of the typical benefits of a high quality roof membrane, EPDM can be installed in such a way to allow for a 30 year warranty against hail damage. The photos below in figures 10 and 11 show EPDM roofs that have been impacted by hail as large as 2½ inches in diameter with no resulting membrane damage, and therefore no leaks.

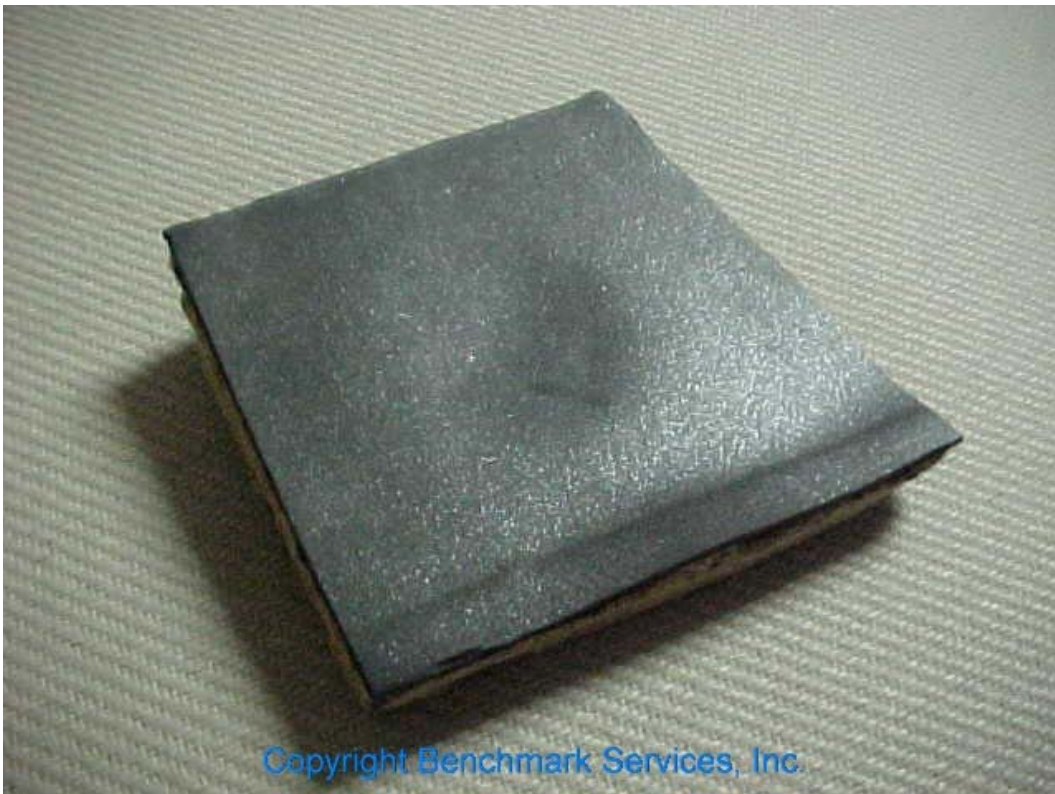
Figure 11 - EPDM Fully Adhered To Fiberboard Insulation, No Membrane Damage
