- From: [eco-structure January-February 2009](#)
- Posted on: May 12, 2009
- **COOL ROOFING**

## Challenging What's Cool

Is the exponential growth of cool roofing an impending catastrophe?

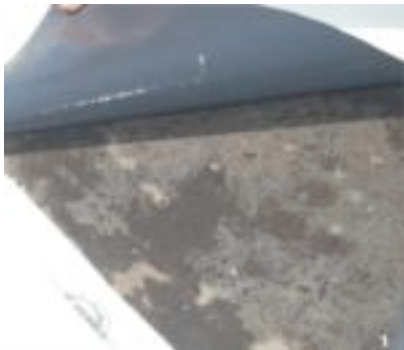
(1) Condensation below mechanically fastened cool-roof membranes in regions with cool nights is resulting in saturated insulation facers below the membrane. The results include mold growth, interior leaking and loss of wind-uplift performance caused by roof-deck corrosion.

Many building owners, design professionals, roofmembrane manufacturers, general contractors and roofing contractors have experienced moisture- saturated roof substrates and, in many cases, ice below the membrane as a result of recent cold winters in the Midwest (see photos 1 and 2). Cool-roofing membranes with single-layer insulation,

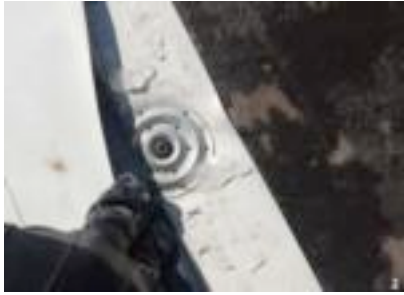
(2) Condensation below cool-roof membranes not only is saturating the insulation but resulting in ice build-up in the lap seams.

Single-layer-insulation applications allow the movement of moisture-laden air through the insulation joints to the underside of the membrane. In cold-temperature regions, this results in condensation. Although condensation can form on the underside of any loose-laid or mechanically fastened single-ply membrane, white membranes tend to accelerate and accentuate the accumulation of moisture because of the membrane's cooler temperatures, which may never be much higher than ambient temperature for the entire winter. This condensation is not just minor moisture accumulating in the roof system; it can be enough to result in ice formation on the underside of the membrane, saturate insulation facers below the membrane and drip into the interior. Ice accumulation in the laps of up to 1/2-inch (13-mm) thick has been observed. Make no mistake, the membrane is watertight and performing well, but the system is failing. This moisture is the first step in the manifestation of mold on the facer, deterioration of the metal roof deck around the screw fasteners with resultant loss of wind-uplift protection, wet spots on the floor, increased potential for the slippage of individuals and/or sliding of equipment, and damaged product. Cooler surface temperatures also are resulting in the growth of mold on the rooftop, which incidentally is where air intakes often are located. Not only are these concerns real in any building in regions that have cold temperatures, the correction is very costly. Many of the buildings affected by condensation are big-box types, totaling hundreds of thousands of square feet. Replacing the roof with a more effective roof system often will cost three to four times the original roof installation cost.

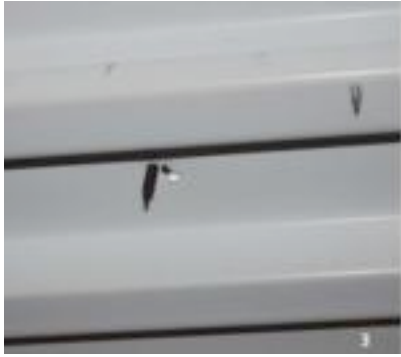
(3) Moisture is dripping out of the errant screw hole. Repetitive wetting will result in roof-deck corrosion and, when located at screw fasteners, loss of wind-uplift resistance.

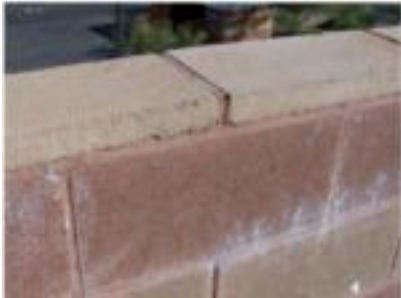
Reflected UV rays caused excessive expansion of this concrete masonry unit, which led to debonding of the coping from the bed mortar joint and debonding of coping head joints. Moisture intrusion is the result. Note the efflorescence.

The result is masonry walls that expand so much the control joints are squeezed shut and mortar debonds, resulting in moisture intrusion that brings about more deterioration. This is particularly acute on parapet walls that typically have less reinforcement than structural masonry walls. It is not unusual to see coping stones pop off the parapet because of expansion. Masonry control joints also degrade under the concentrated UV radiation, which allows for moisture intrusion and subsequent deterioration. Reflection also affects other cladding materials, such as EIFS. EIFS systems have been known to absorb so much heat that certain insulations behind the cementitious coat, such as low-density expanded polystyrene, reportedly are melting away. Colin Murphy, RRC, FRCI, reported in a white paper for the Raleigh, N.C.-based Roof Consultants Institute

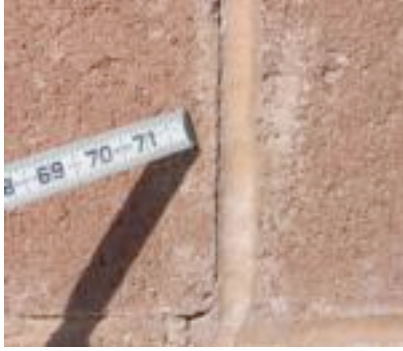
Reflection from the cool-roof membrane field sheet onto adjacent masonry parapet walls is resulting in excessive expansion and debonding of the mortar joints

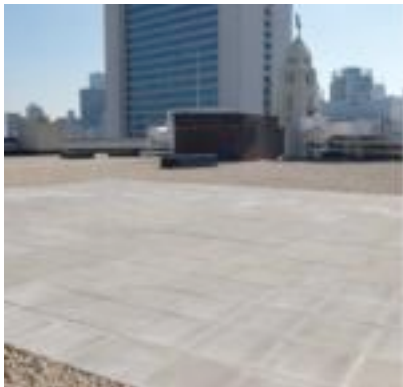
**A roof system featuring concrete pavers and ballast in Chicago now is accepted by Chicago Code as a cool-roof system.**

Oak Ridge, Tenn.-based Oak Ridge National Laboratory and the Waltham, Mass.-based Single Ply Roofing Industry recently issued a report that concludes after three years of

testing that concrete pavers and ballast coverage of 17 pounds per square foot (83 kg/ m<sup>2</sup>) or greater provide benefits greater than actual cool-roofing membranes.

The shade from the ballast also protects the membrane. Based on this report, the Sacramento-based California Energy Commission; Atlanta-based American Society of Heating, Refrigerating and Air-Conditioning Engineers Inc.; and city of Chicago have realized the benefits of ballast, giving designers another cool-roof-system option from which to choose. To learn more about ballasted roof systems as a cool-roofing option, read “Evaluating the Energy Performance of Ballasted Roof Systems” on SPRI’s Web site, [www.spri.net](http://www.spri.net), or search “ballasted roof” on [eco-structure.com](http://eco-structure.com).
